# Manhole Inspection Summary

Manhole # S43E\_\_051MH

Insp Date: **6/9/08 2:24 PM**

**Location** Address: **1608 e fairmount st**

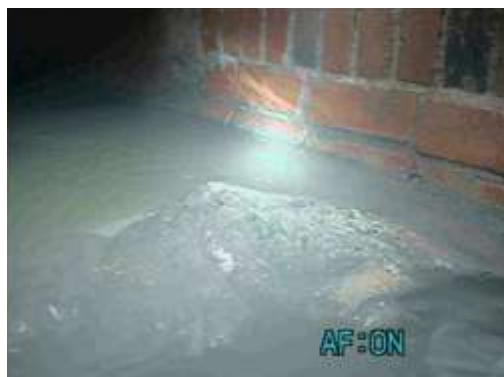
misc

bench debris

channel debris

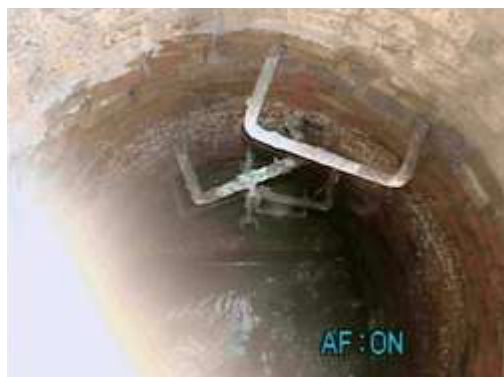
Defect 3

Count: **5** Missing: **0** ☒ **Corroded**

inside of Pipe In @ 6 OClock

corroded steps

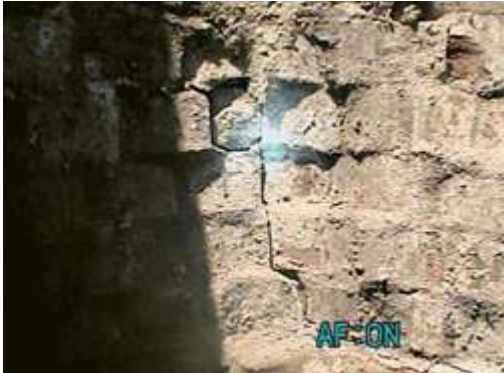
Defect 2

Condition: ☐ Sound ☒ **Cracked** ☐ Root Intrusion ☐ Loose Brick ☐ Deteriorated

crack in corbel

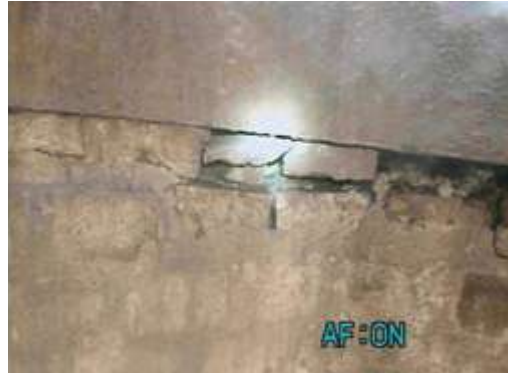
Defect 1

Condition: ☐ Sound ☒ **Cracked** ☐ Root Intrusion ☐ Loose Brick ☐ Deteriorated

cracked chimney, frame adj

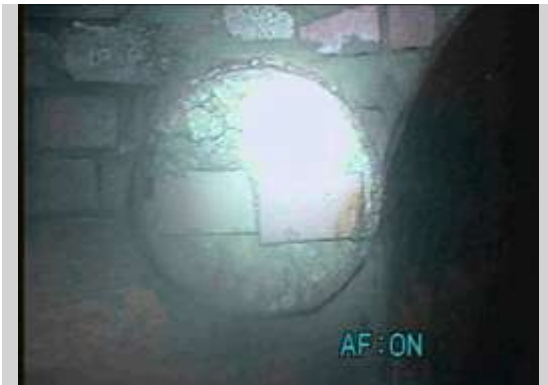
5 O'Clock Inflow

abandoned connection
